Cabinet Appointed
Expert Committee
to Investigate the
Causes of the
Islandwide Power
Outage on
Wednesday 16th
February, 2022

Report

April 2022

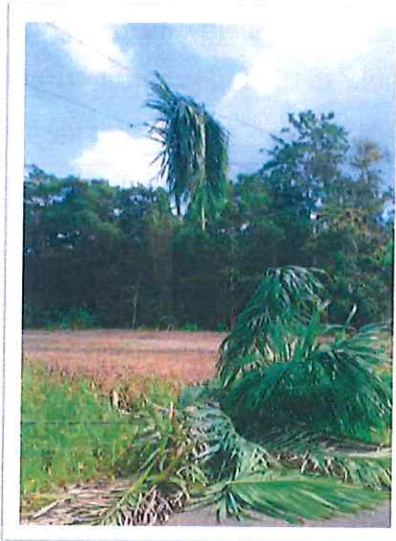
Figure 1: Photograph of fallen Palmiste tree

The triggering event for the incident was the impact of a fallen Palmiste tree on a single phase 12 kV distribution line. This is captured in Figure 1 and Figure 2. It should be noted that at the time of the fault, the country was under a Yellow Alert issued by the MET Office (*see Appendix 4. ii*). The said distribution line was crossing orthogonally under the 220 kV line circuit Union to Gandhi (U-G) between towers #53 and #54. The U-G 220 kV twin circuit is responsible for exporting most of the power from the TGU generating facility. A small quantity (70 MVA max) goes through the 66 kV bus to Brighton. This 66 kV circuit is colloquially termed the "back door". The 220 kV U-G corridor is composed of two circuits, one on either side of each tower. The result was a ground fault developed on both circuits. The protective devices operated and isolated both circuits, clearing the fault.

A review of the fallen tree, by the Forestry Division, Ministry of Agriculture Land and Fisheries (see Appendix 4. iii) indicated that the windy condition at that time, with the fungal infection and heavy rotting at the base of the tree, caused the tree to fall. Hence this incident was due to natural causes. The team spent some time

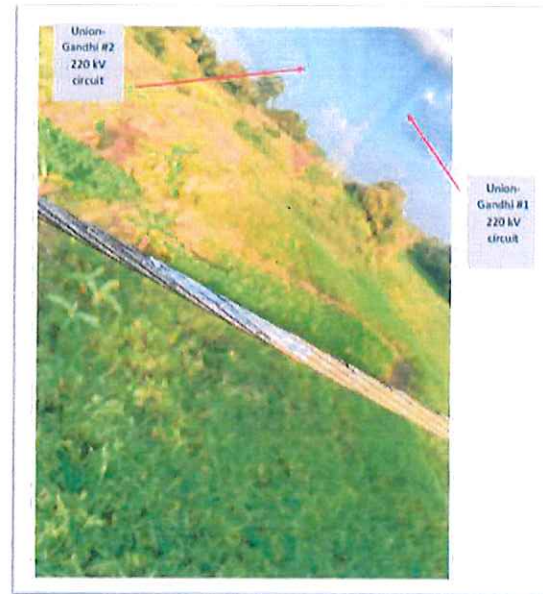
Figure 3: Scorching of the 12 kV conductor

An investigation of the affected lines after the incident showed evidence of severe scorching (see Figure 3) where the 12 kV line came into contact first (at 12:51:57.59 pm) with the blue phase of the 220 kV Circuit #2 and then shortly after (12:51:58.02 pm) with the blue phase of the 220 kV Circuit #1 of the U-G 220 kV lines. Using a drone, similar scorching marks were seen on the blue phases of the 220 kV lines above it.

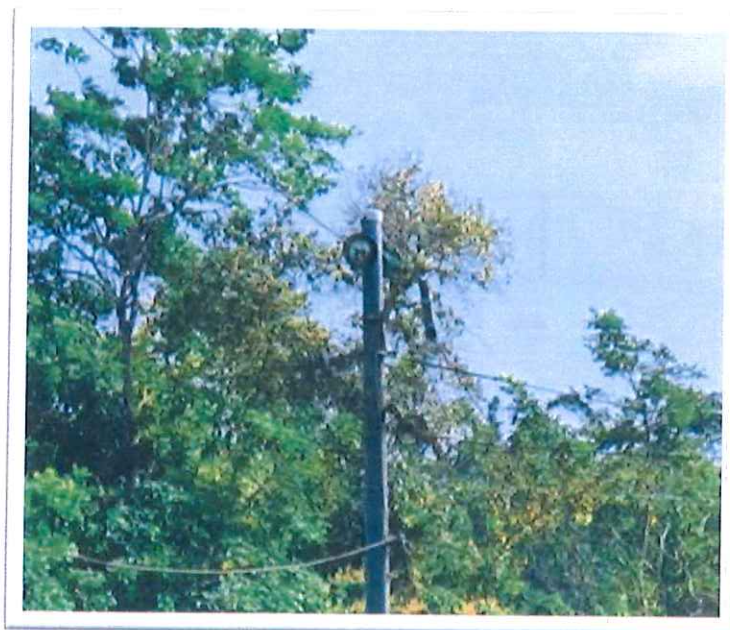
Figure 4: Top of pole 72

A recreation of the incident on the day indicated that the Palmiste tree first struck the 12 kV line between poles 72 and 73, pulling this line into rigid tension. The line was connected to pole 72 using a dead-end porcelain insulator as shown in Figure 4. This caused the top of pole 72 to bend in tension towards the fallen tree.

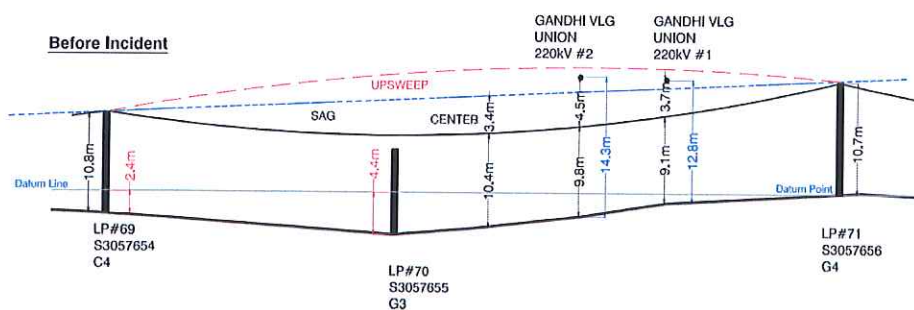
Figure 5: Standing Wave

line to oscillate like a plucked guitar string albeit heavily damped after the first half wave. The first oscillation caused a whipping of the conductor to produce a wave whose initial amplitude was equal to the sag on the line. This caused the conductor to come into contact with the #2 circuit first and then the #1 circuit as shown in Figure 5.

In Figure 5, the black line represents the line position before the tree fell. The blue line represents the taut line whilst the tree was on the 12 kV conductor and the red line represents the first oscillation of the line. As can be seen from the upswing of this line it will, due to the normal sag, contact the 220 kV circuits. This initiated the collapse of the electricity grid on Wednesday 16th February 2022.

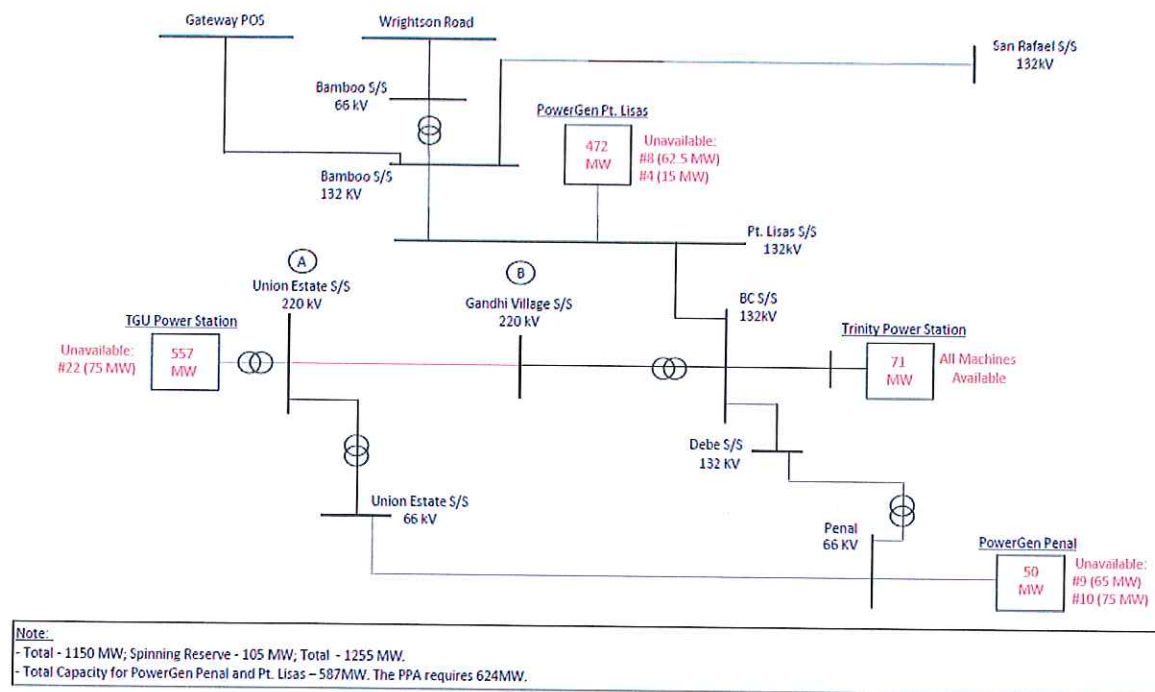
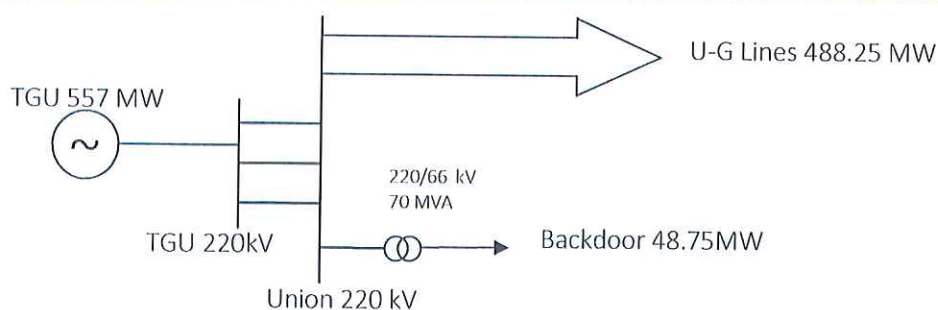
Figure 8: System power flow at fault time (top) and TGU power flow (below)

At the time when the U-G lines tripped, the Union 220 kV substation was still connected to TGU by the three lines from the power plant. The clearing of these two Union Gandhi Village lines however, left TGU's 557 MW (20 MW feeds internal load at the plant) of online generation, trying to continue to supply the island through the 70 MVA transformer to Point Fortin (the "backdoor"). Within milliseconds of the fault, this line then saw a sudden increase in power flow to 141.5 MW as the plant tried to divert the lost 537 MW that it was delivering via the U-G circuits through this 66 kV corridor to the rest of the power system (See Figure 8). This caused the 220/66 kV 70 MVA transformer at Union substation to immediately trip on overload.

The large imbalance between available running (on the bars) generation supply (557 MW) and load (68.75 MW) resulted in a very rapid increase in generator speeds at TGU, as the essentially unloaded turbines accelerated. The data shows that the frequency increased very rapidly from 59.87 Hz to approximately 70.35 Hz (114%) in 570.3 milliseconds. The primary overspeed trip on the gas turbines are (Manufacturer) set at 110% (66 Hz) and a secondary trip at 112% (67.2 Hz) to protect the machine from physical damage from rotating too fast. Thus, the TGU turbines tripped on overspeed protection, disconnecting all the generators at TGU from the transmission network. On the northern section of the electricity grid, there was a large imbalance between available running (on the bars) generation (736.7 MW) and load (1196.5 MW). This resulted in a 459.8 MW deficit that manifested as a very rapid reduction of generators' speeds and system frequency. As intended, the automated underfrequency load shedding scheme, shown in Figure 9, was initiated to attempt to rectify the imbalance.

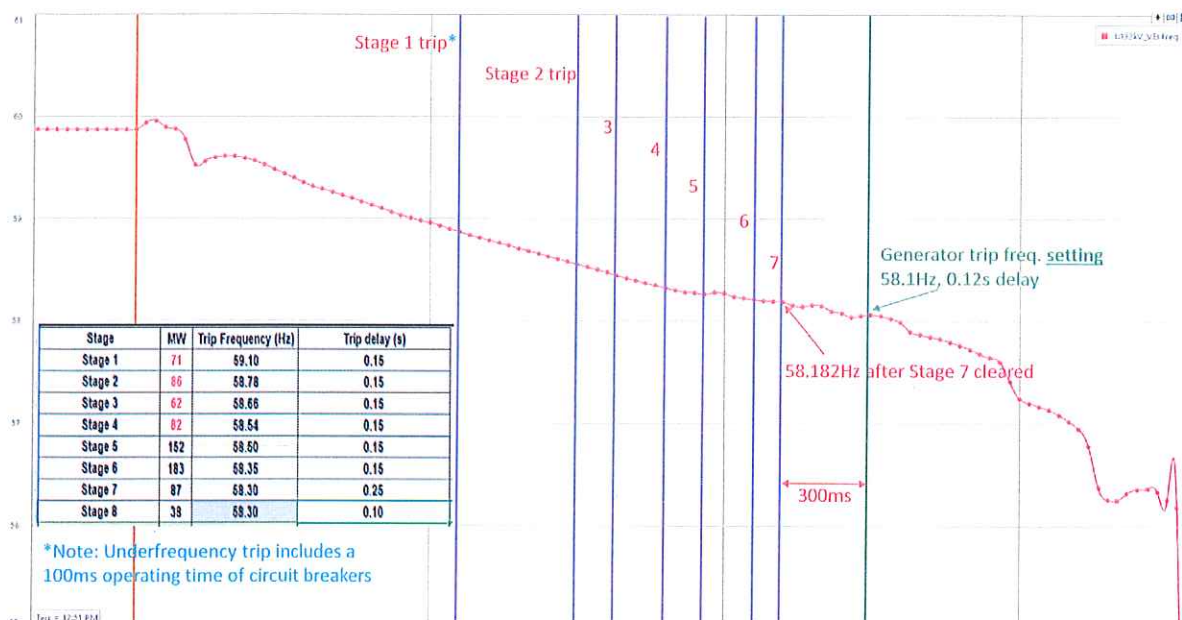
Figure 9: Underfrequency load shedding scheme

Whilst the total load shed in the time window by this automated scheme was insufficient to rectify the imbalance, there was a more critical issue in that the rate at which the frequency was decaying, was too fast for the system's circuit breakers to physically respond to remove loads from the network to match the available generation. The time taken for the load shed scheme to fully operate, allowed the frequency to fall to a point where all the Point Lisas and Penal generators tripped on underfrequency protection. As more generation was lost the frequency fell even faster, creating a cascading domino effect. The end result of which was that all the generating facilities in Trinidad tripped *within 3.6 s* of the initial fault.

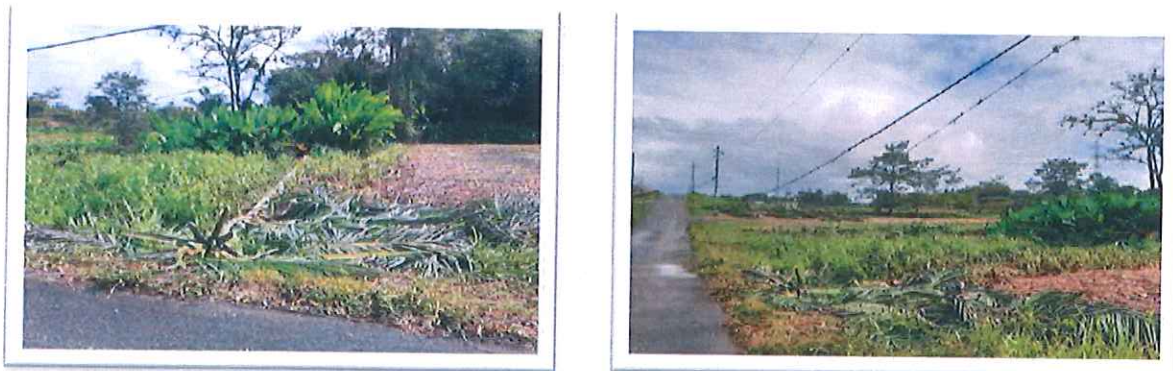
Figure 14: Fallen Palmiste tree (*Roystonea Oleracea*) at Grant Trace Extension, Rousillac

At 10:30 am on Wednesday 16th February 2022, the TTMS issued a national yellow alert of high winds for Trinidad (*see Appendix 4. ii*). At 12:52 pm the said day, a *Roystonea Oleracea*, commonly called a Palmiste Palm, measuring fifty-eight feet six inches (58' 6"), fell and brushed a T&TEC distribution line located between LP 69 and LP 71 Grant Trace Extension, Rousillac causing a "whipping motion" that resulted in the upward reversal of the natural sag on the line. See Figure 5 and Figure 14.

The resultant wave on the distribution line, came into contact with the blue phases of the overhead TGU 220 kV transmission line causing both circuits to trip.

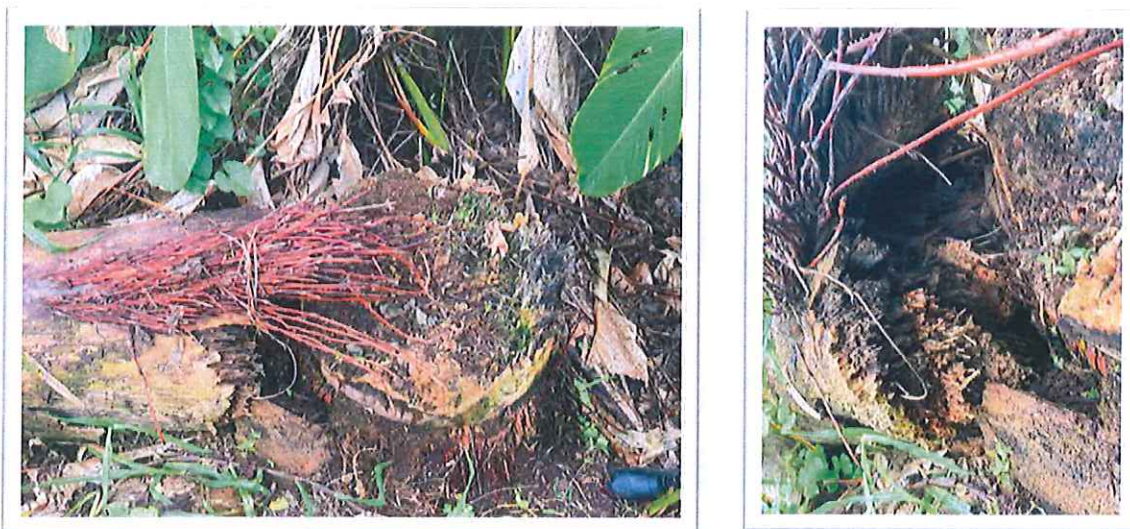
Figure 15: Photographs showing heavy rotting and fungal decay

The Committee re-visited the site of the initial fault at Grant Trace Extension, Rousillac with Mr. Jason Mungalsingh, Forest Officer I attached to the Southwest Conservancy of the Forestry Division of the Ministry of Agriculture, Lands and Fisheries. Mr. Mungalsingh examined the fallen Palmiste Palm (*Roystonea Oleracea*) and determined that the tree (Figure 14 and Figure 15) *"showed signs of heavy rotting and fungal decay"*. He also concluded that *"there was no evidence of power saw markings or cutlass blazes to indicate felling by human intervention"* and deduced that *"given the height of the tree when it was standing and the heavy rotting at the base, it can be concluded that the tree fell due to natural occurrence"* (see report at *Appendix 4 iii*).
