Cabinet Appointed
Expert Committee
to Investigate the
Causes of the
Islandwide Power
Outage on
Wednesday 16th
February, 2022

Report

April 2022

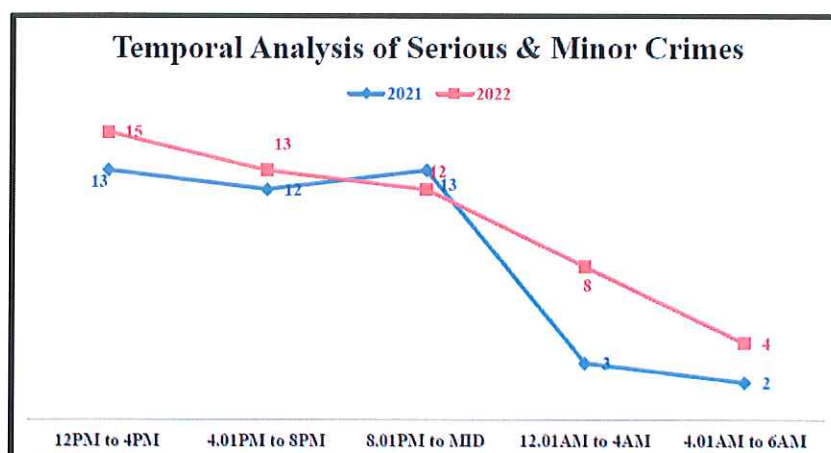
Hereunder depicted is a CAPA *"Temporal Analysis of Serious & Minor Crimes"*. It is a comparison of all reported crime which occurred on Tuesday 16th February 2021 as compared against Wednesday 16th February 2022, which notes no significant increase in all categories of crime during the event. In examining the TTPS Critical Incident Event and Disaster Management Plan and Policy (*see Appendix 4 vii*), it was clearly evident that despite blackouts not being included in the plan, other than as a side effect of *"thunderstorm activity"*, the organisation catered for such dynamic eventualities and this critical incident would have been defined under a *"Level 3 Rating"*, as it was one which affected *"multiple divisions and or sections"*, and which required *"the involvement of resources from external agencies at a national level"*.

Figure 16: Temporal Analysis of Crimes on February 16th 2021 and February 16th 2022. Source – TTPS CAPA.

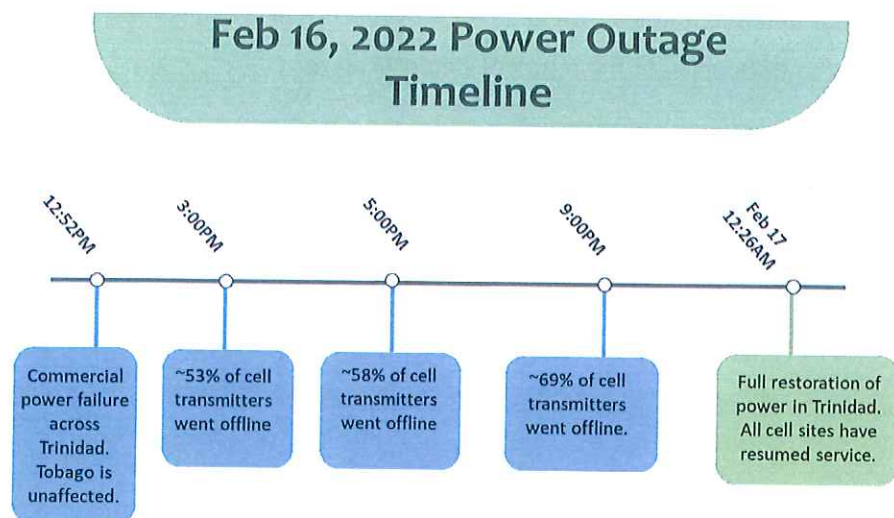
Conversely, the power outage adversely affected TSTT as the company reported to the Committee via correspondence Ref. No.: 10000/049/2022 (see Appendix 4 xi) that one of the most *“critical challenges posed by the outage was the extended period in the restoration of commercial power which led to the Wireless Transmitter sites that were on battery backup having exhausted the designed capacity going offline. Over half of the mobile network elements lost power in a rolling outage pattern at approximately four hours (4) after the start of the outage”*. The company highlighted that its *“radio access network in Trinidad was severely affected resulting in a degradation of service in some cases and a full loss of services in others”*.

Figure 17: TSTT power outage timeline. Source: TSTT Report Ref. No.: 10000/049/2022

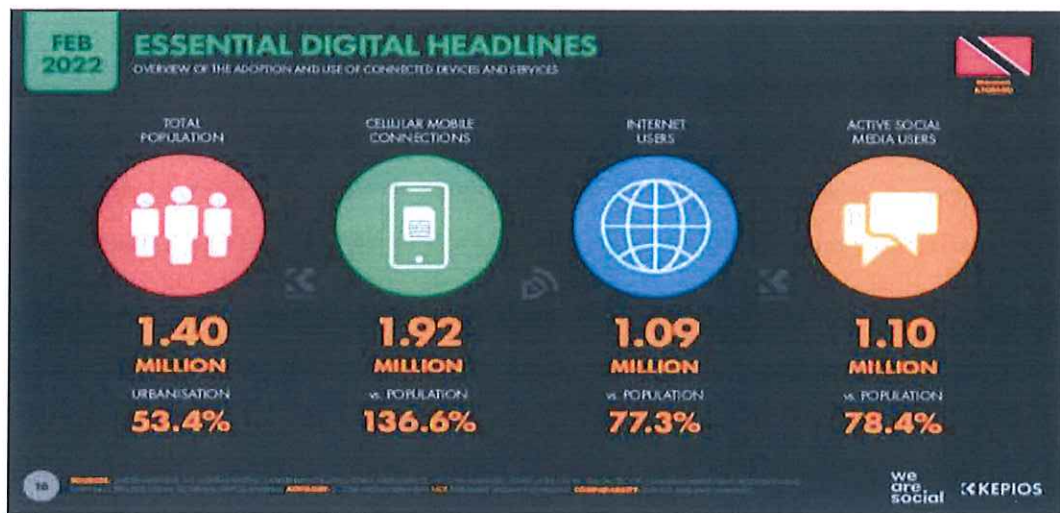
Figure 18: Connected devices. Source: TTPS – RAU Report RAU2022RR001

In examining the actual reach of social media on the day of the blackout, the RAU posited that this would depend heavily on the number of customers on both networks who had connectivity, considering that Wi-Fi connections would have been affected. The Committee found that the more applicable solution would have been to utilise an integrated system of SMS type notification system; AM/FM Radio; a myriad of social media platforms; website; mobile apps and email, similarly to what is utilised by the TTMS. The Committee noted that considering T&TEC's role as a sector lead, whose mandate was the transmission and distribution of electricity, the company should not have been the primary source of communication to the public and this remit should have fallen to the agencies whose primary responsibilities include mass communication.
